PROPERTY INSPECTION REPORT

██████████ Lane, Frisco, TX 75035

PROPERTY DESCRIPTION: Single family residence, 5,000 SF, constructed in 2020

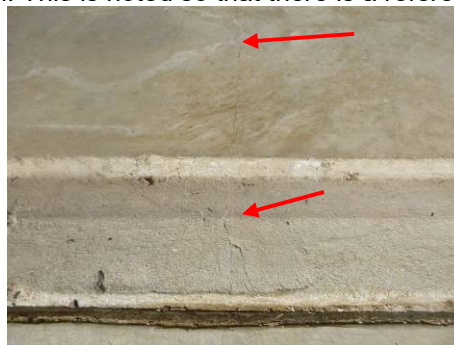
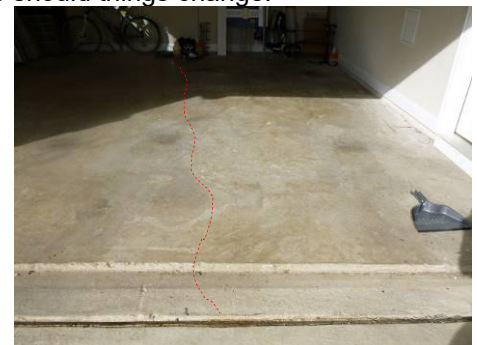
Surface crack(s) observed at the garage floor. It is common to have some surface cracks in the cement finish and common that there may be more cracks beneath interior floor coverings. These cracks do not suggest that there is a structural issue presently. This notation is added as a reference for future comparison. Monitor this condition and make note if it changes overtime.

There are cracks in the garage floor and one that stands out more than the others which runs north and south. This is noted so that there is a reference should things change.

There are cracks in the garage floor, one stands out more than the others which runs north and south. This is noted so that there is a reference should the crack enlarge.

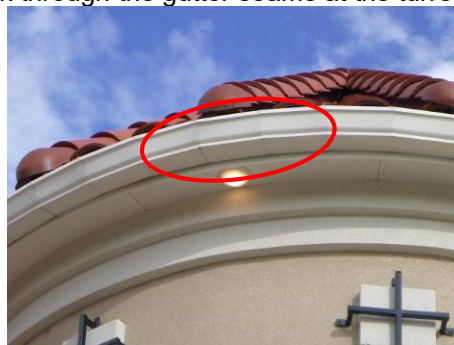
[X] There is a leak through the gutter seams at the turret.

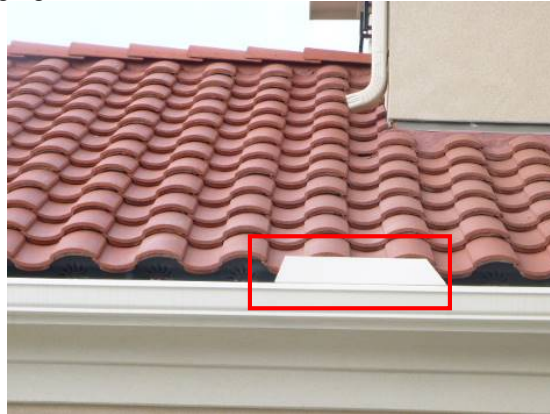
[X] The owner pointed out to me that the water diverter attached to the gutter above the garage door is not managing the water runoff from the roof.

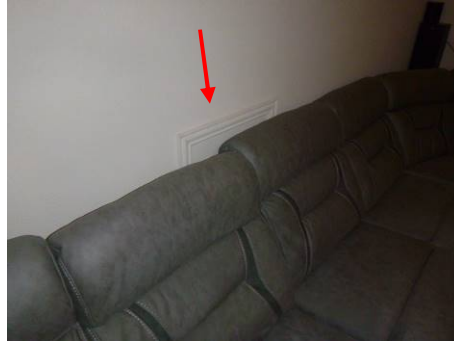
3] media room - Access panel is sealed shut, inaccessible. It was also inaccessible at the time of the inspection on 03/16/2020.

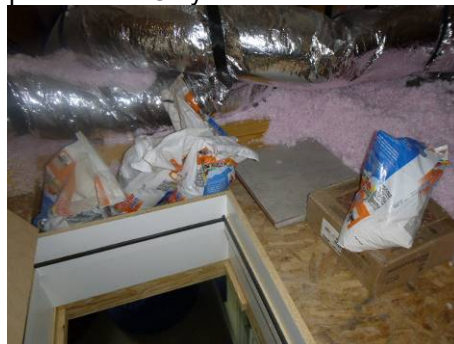
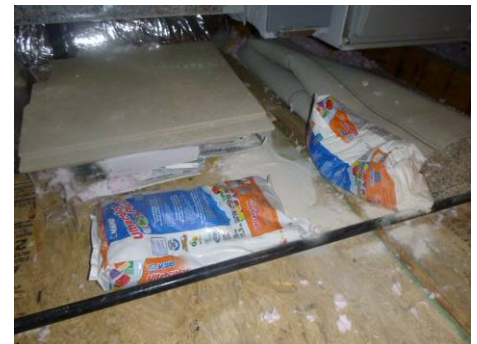
There are some building supplies stored in the upper attic space by the access ladder and beneath the upstairs HVAC system.

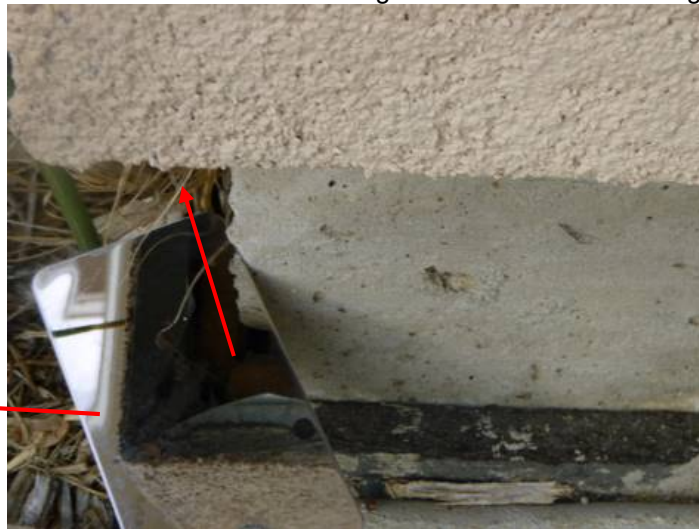
[X] Through the mirror I can see this unsealed edge at the SE corner of the garage.

The mirror shows the unsealed opening exposing the wall framing

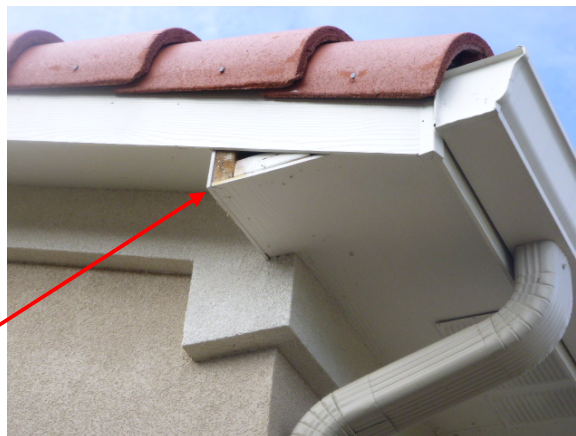
[X] Exterior a small piece of the fascia board end cap is missing at the southeast corner of the master bedroom.

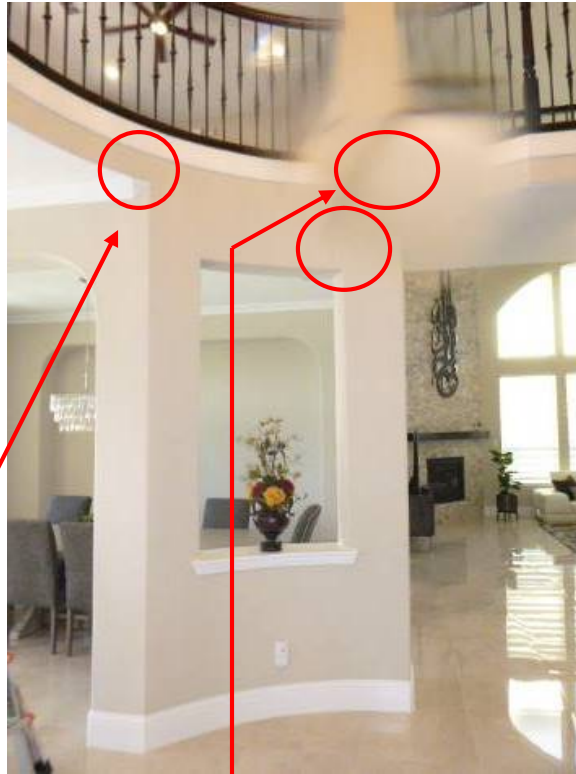
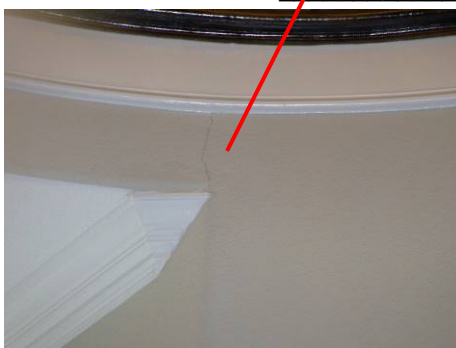
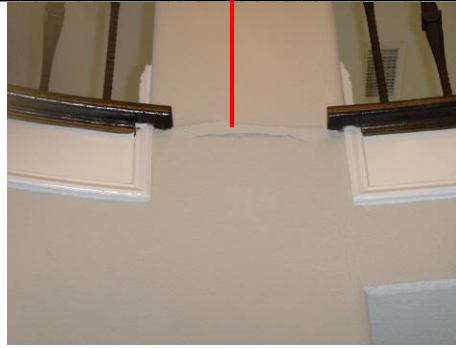
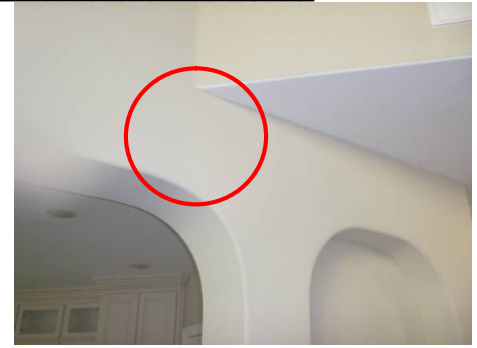
[X] **Interior stress cracks in sheetrock observed at the rotunda.** There is a compression crack at the post that extends from the ground floor to the second floor ceiling. There are diagonal cracks at the arches left and right of the column and another crack at the living room where the balcony meets the media room.

[X] Interior stress cracks in sheetrock observed at the rotunda. There is a compression crack at the post that extends from the ground floor to the second floor ceiling. There are diagonal cracks at the arches left and right of the column and another crack at the living room where the balcony meets the media room. Review with the builder as to what the solution will be. New homes do go through an adjustment phase during the first year or two.

Review with the builder as to what the solution will be. *New homes do go through an adjustment phase during the first year or two.*

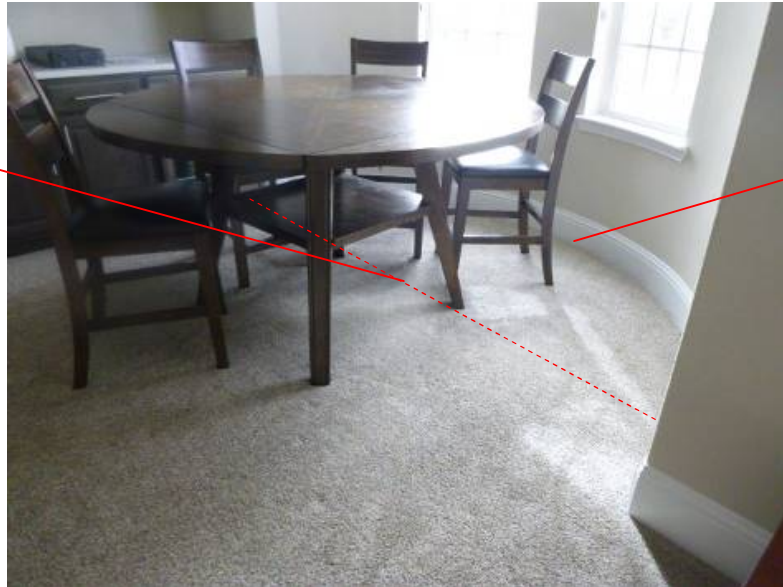
[X] Floor is out of level at the upstairs game room, card table area. There is a rise in the floor that travels north and south from the beverage refrigerator to the north wall opposite. From this rise (which is likely a beam within the floor design) the floor drops 3/4 inch in four feet from the beam to the exterior wall.

Floor is raised along this line.

The floor drops 3/4 inch to the outside wall

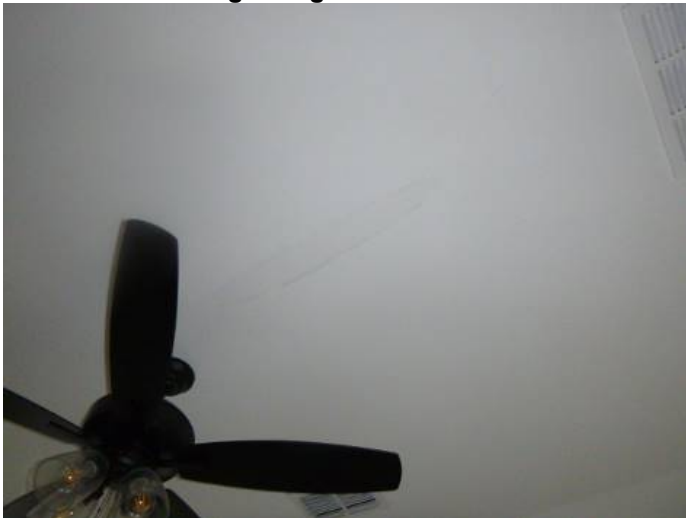
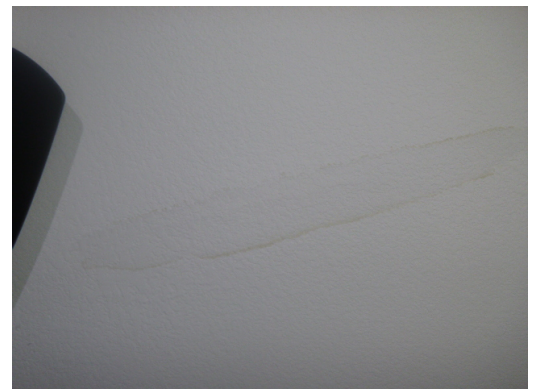
[X] **There is a water stain at the ceiling of the upstairs north bedroom. The moisture may be associated with the roof covering above the stain.** The roof was not walked on today due to the possibility of breaking the tile. The builder will need to do their own assessment regarding the water stain.

[X] There is a water stain at the ceiling of the second floor north bedroom. There are notes regarding this observation in the roofing section as well.

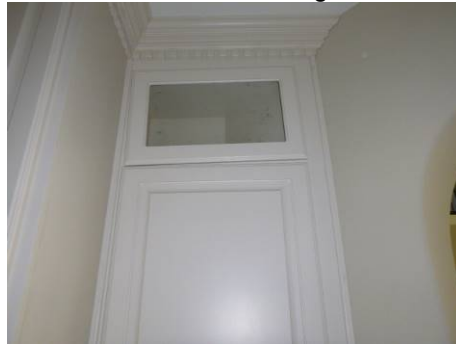
Upper west kitchen cabinet door is out of alignment.

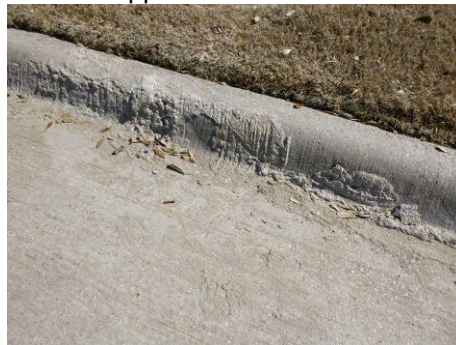
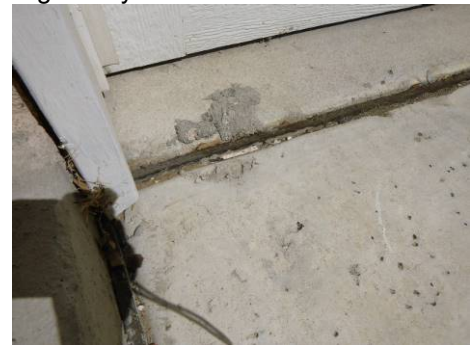
Excess cement could be chipped free at the curb and the garage entry.

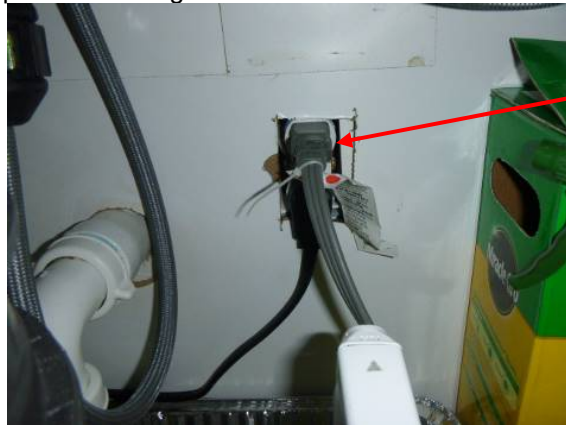
[X] Outlet: Cover plate is missing beneath the kitchen sink.

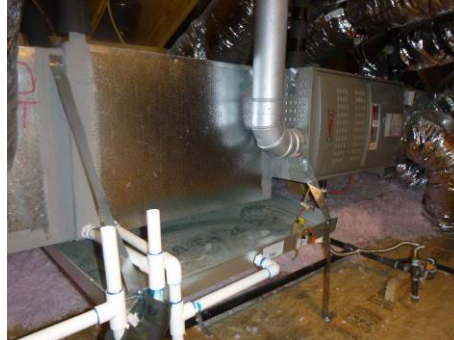
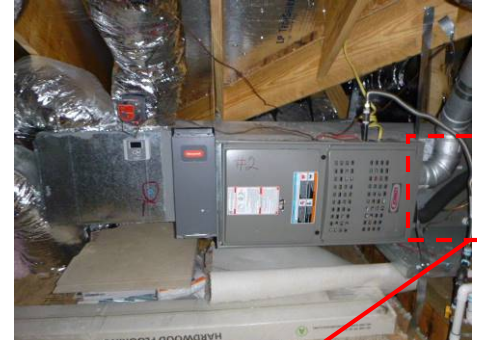
There is no decking beneath the evaporator coil of the upstairs unit. This makes it difficult for the HVAC mechanic to

IRC code 2003 (M1305.1.3) Appliances in attics. The passageway shall have continuous solid flooring in accordance with Chapter 5 not less than 24 inches wide. A level service space at least 30 inches deep and 30 inches wide shall be present along all sides of the appliance where access is required. The clear access opening dimensions shall be a minimum of 20 inches by 30 inches, where such dimensions are large enough to allow removal of the largest appliance.

[X] THIS decking does not meet the current criteria be careful when servicing the equipment. The upstairs unit is missing decking in front of the evaporator coil.

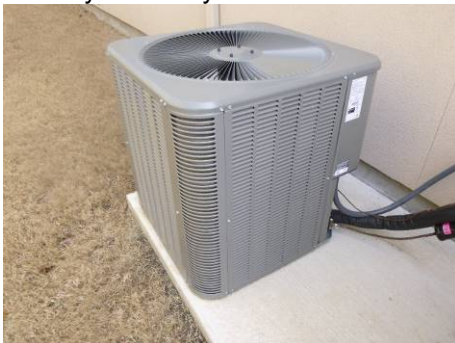
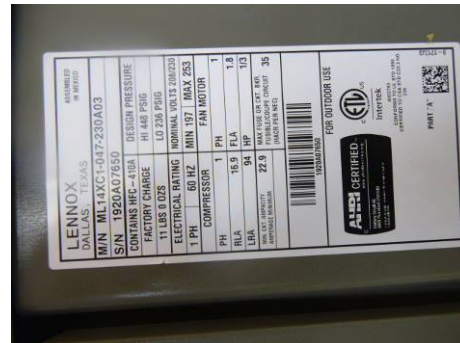
[X] It is approximately 20% dirty.

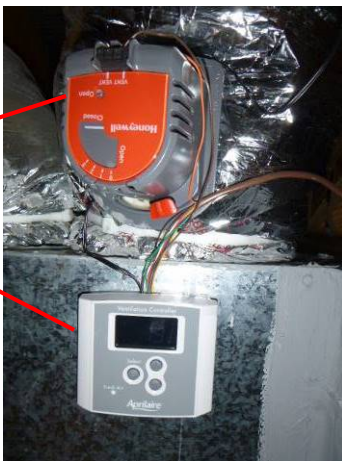
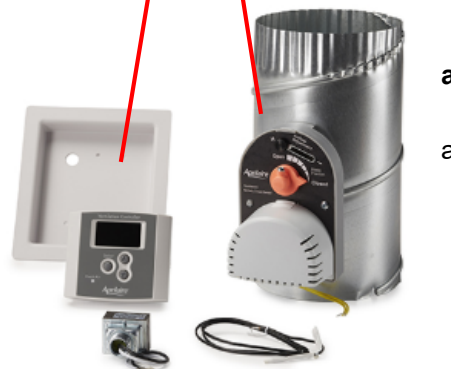
Two different manufacturer components were installed for the fresh air ventilation system?

HOWEVER The electronically controlled damper is Honeywell component? Ask the builder about this.

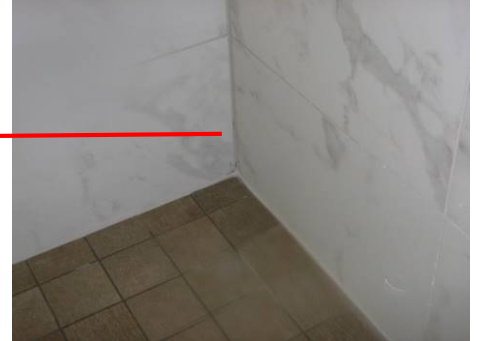
[X] Shower - Vertical tile inside corner at the seat needs to be sealed. There is a crack through one tile at the north lower corner of the glass panel separating the shower from the tub.

Reseal this
inside edge

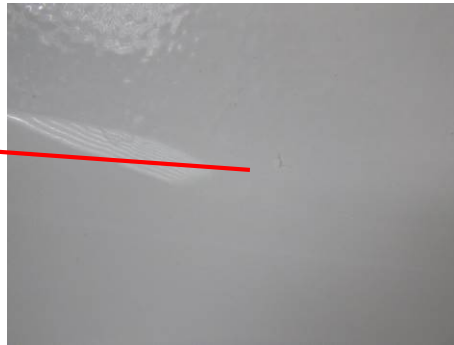
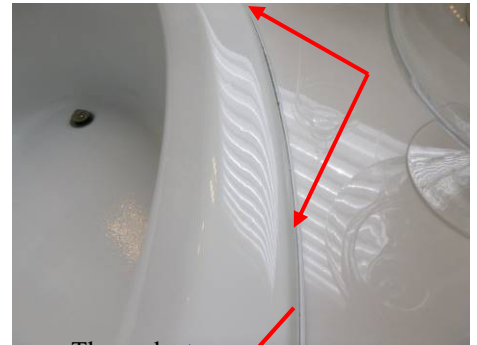
[X] Tub – The tub sealant is open along the back edge of the tub. There is a nick in the tubs surface.

Nicked
surface finish
inside the tub

The sealant
has separated

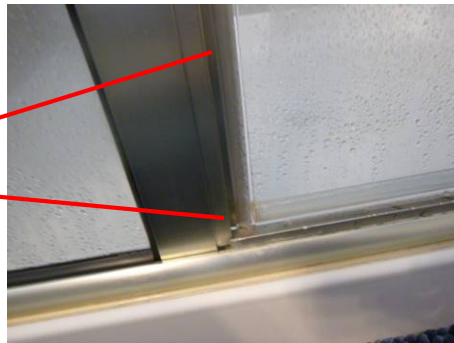
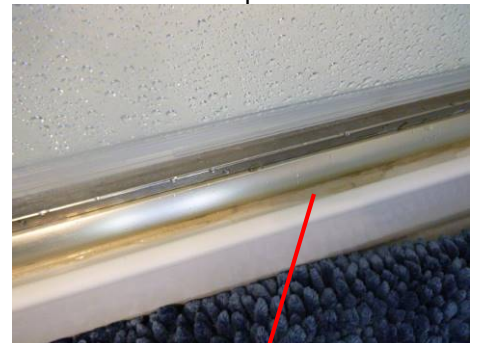
[X] Shower – the door does not make a complete seal to the neoprene door frame at the bottom, there is a gap. The silicone seal between the door rail in connection the shower pan is loose.

Gap between the
door and door
frame seal

The silicone seal is
detached and there is
moisture in the track

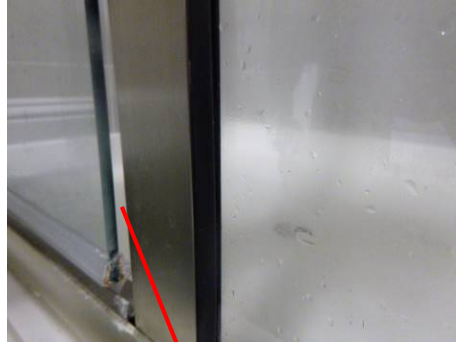
[X] Shower – There is a crack in the face of the shower pan. There is a gap between the door and the door frame (the door alignment is off)

Gap between the door and door frame seal

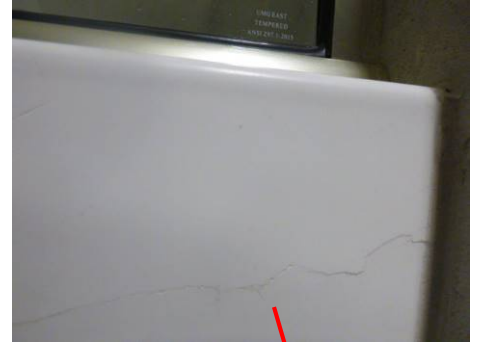
Cracked drain pan

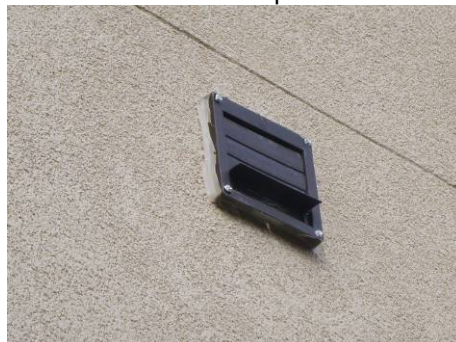
[X] One master bath exterior vent flap does not close when not in use.

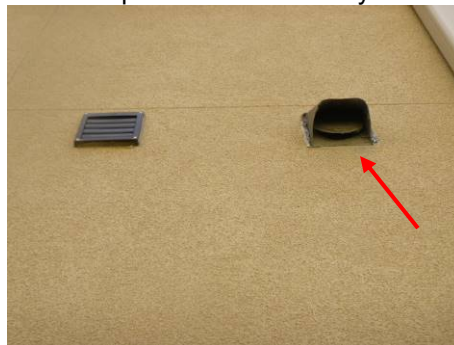
[X] The exterior vent flap does not close fully when not in use.

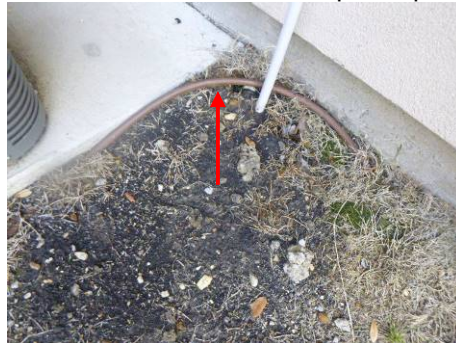
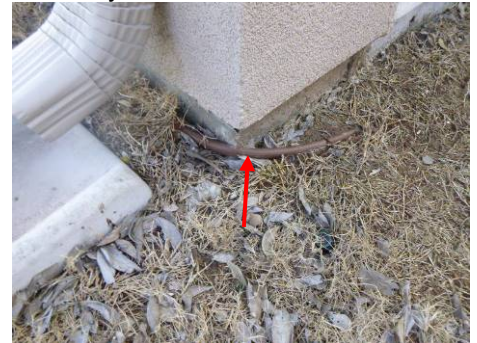
[X] Station #10 some of the foundation drip is exposed . . . mostly on the north elevation.

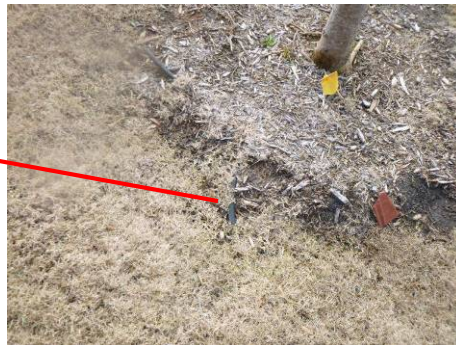
[X] Station #11 the exposed irrigation line for tree bubbler is subject to damage from the lawn service.

Outside of the tree ring.

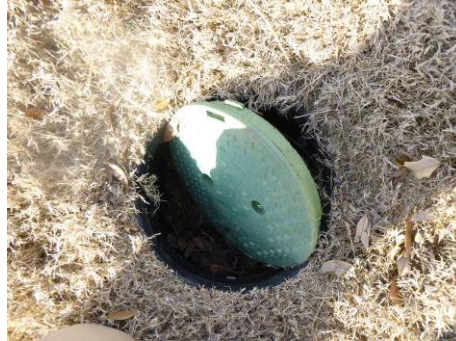
[X] One solenoid valve cover was inside the valve box. The valve box cover locking tabs are broken off. At the time of the inspection 03/16/2020 this lid was missing.

- [X] One solenoid valve cover was inside the valve box. The valve box cover locking tabs are broken off therefore the cover does not stay attached as intended.
